•	- CONFIDENTIAL		REPORT	
				25X1
COUNTRY Poland			DATE DISTR. 3	0 bet: 53
SUBJECT 1. Rumis 2. Wrzes	Airfield zcz Airfield		NO. OF PAGES	4
PLACE ACQUIRED			NO. OF ENCLS.	2
DATE ACQUIRED			SUPPLEMENT T REPORT NO.	o 25X1
DATE OF IN				
gyddigwydd yng gwed o fael o chogagaeg y Caellan	THIS IS UNEVALUATED INFORMATION	_ DN		25X1

Enclosure 1, RUMIA: This field is located on the northwestern outskirts of the town of Rumia. It is a grass field without runways. Its measurements are roughly 1,300 m. x 900 m. The NW and SE edges of the field are lined with bushes four feet high. There is a row of trees along the western half of the field's southern border.

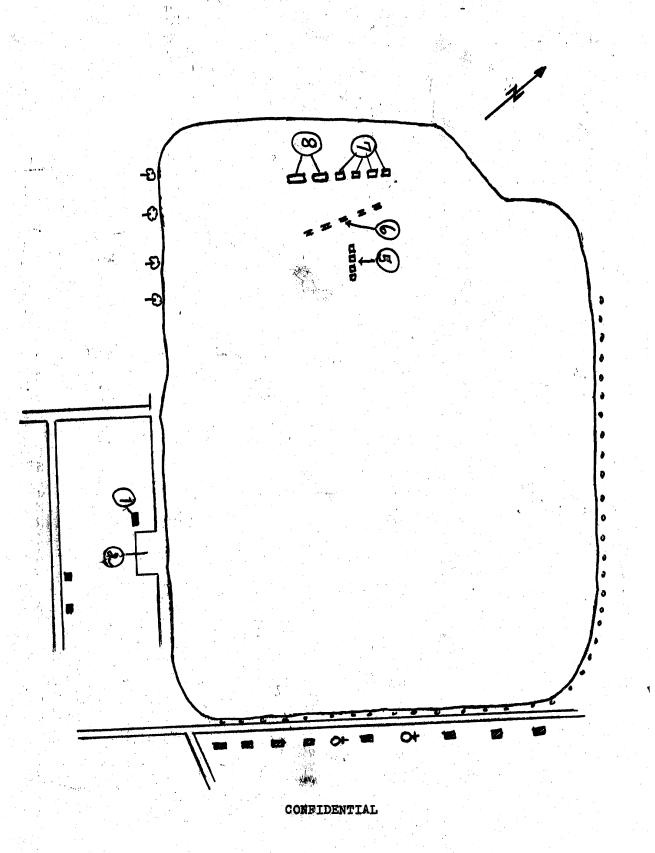
Enclosure 1, Rumia

- LEGEND POINT 1. Barracks: for permanent detail of 5-10 sailers. They are responsible for the upkeep of the field. It is a wooden building, 10 x 5 x 3 m.
 - 2. Ruins of a hangar: was destroyed by the Germans during their retreat through the area.
 - 3. Civilian church.
 - 4. Civilian church.
 - 5. Four wooden automobile targets. They were used for strafing practice by fighters and attack aircraft.
 - 6. Five wooden tanks. They were used for strafing runs by YAK-9-P fighters with 23 mm. cannons.
 - 7. Four targets: six by six meters square, of plowed earth.
 They were mainly used by attack planes for strafing runs.

Two targets: six by twelve meters, same conditions as above.

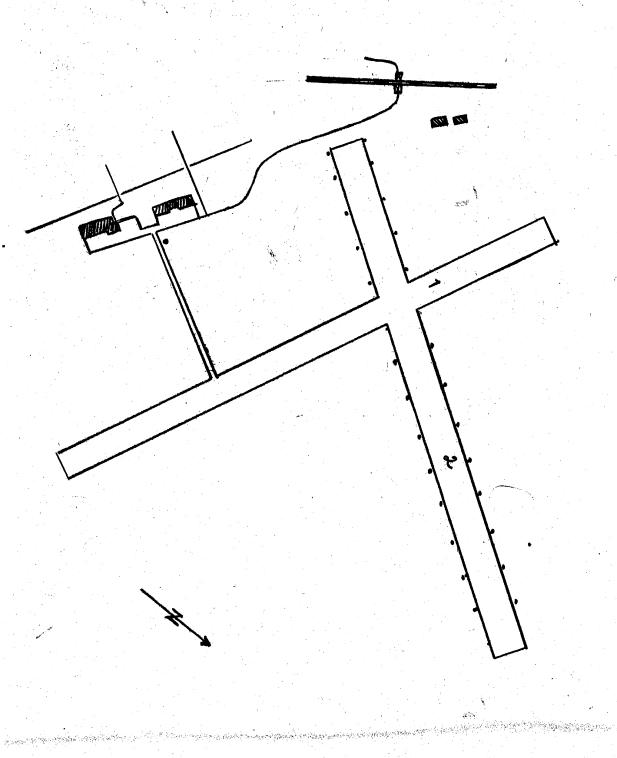
Enclosure 2, Wrzeszcz

this is a small field waw of Gdansk on the northern outskirts of the town of Wrzeszcz. It is a fine of the town of Wrzeszcz. It is a fine of the town of Wrzeszcz. civilian field under the control of the PLL-LOT (government airline of the Ministry of Communications). This airline uses the Douglas C-47 Une Ministry of Communications). This airline uses the Douglas C-47 Dakotas. Approximately 12 flights a day are flown to Szczecin, Lodz, Warsaw, and Poznan, six early in the morning and six in the evening. The Polish Naval Air Division utilized this field only in the event that inclement weather closed down the field at Oksywie. Runway #1 has a length of approximately 2,000 m., a width of 60 m., and a concrete thickness of 15 cm. Runway #2 is 2,000 m. long, 80 m. wide and a 15 cm. thickness of concrete. Runway #2 has runway lights for night flying. The flight approach to runway #2 is dangerous due to the location of the bridge SW of the runway. The woods near the SE end of the runway are approximately eight meters high. A hill 50 m. high is located at the approximately eight meters high. A hill 50 m. high is located at the approach to runway #1. in view of these obstacles it was too dangerous for jet aircraft to use this field.
